# Case study 14. The Bowmont Catchment

**Authors:** Mark Wilkinson, Steve Addy (James Hutton Institute), Luke Comins, Hugh Chalmers (Tweed Forum)

**Main driver:** Flood risk management and river morphology improvements

**Project stage:** Partially constructed (works are ongoing)

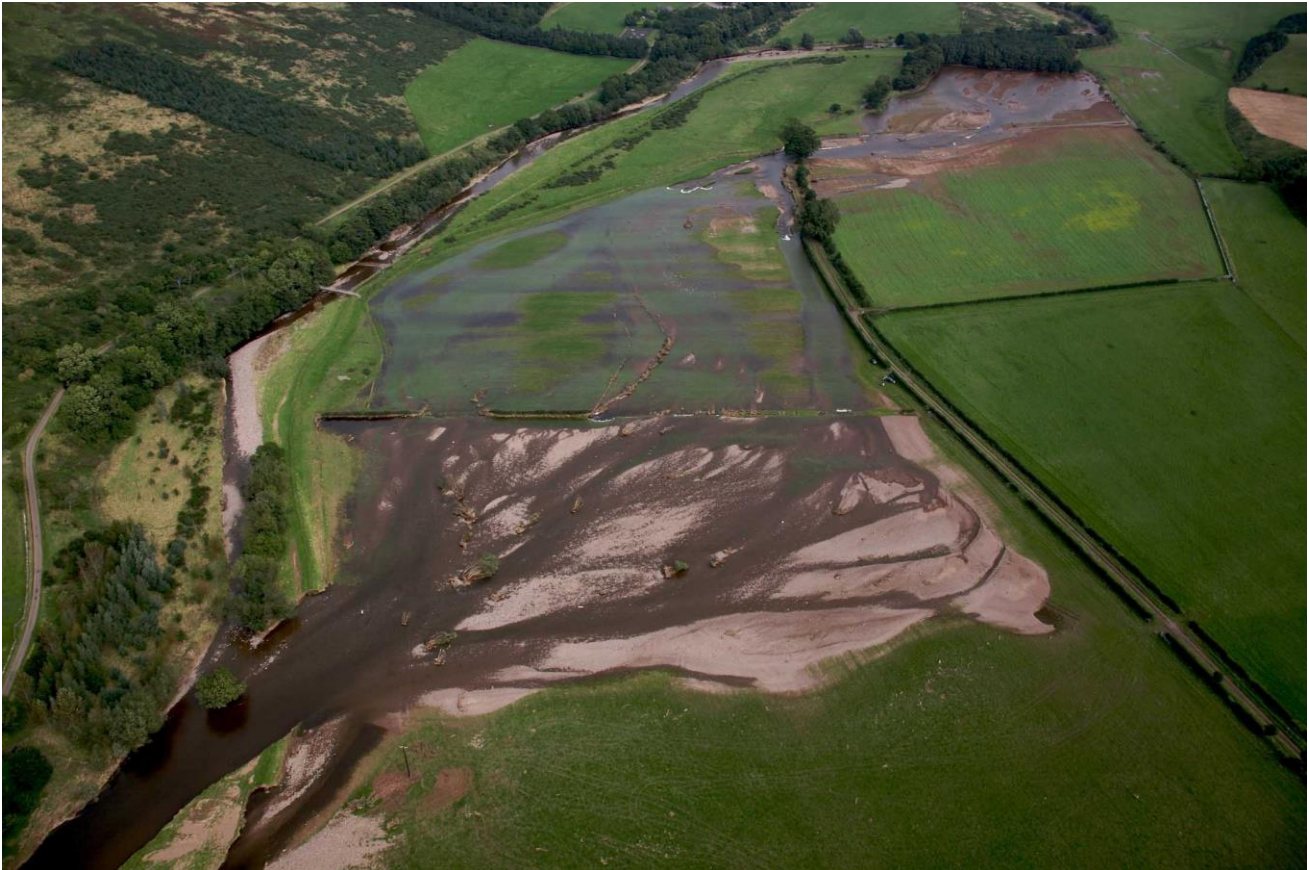
**Photo 1:** An avulsion on the River Glen (downstream continuation of the Bowmont in Northumberland) caused by the September 2008 flood event

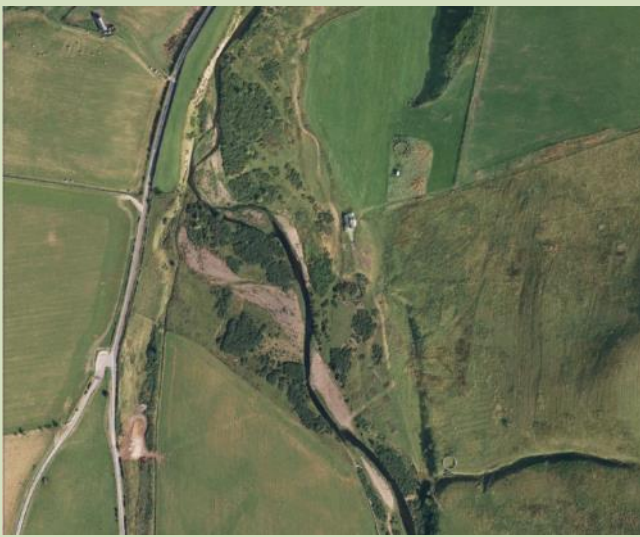
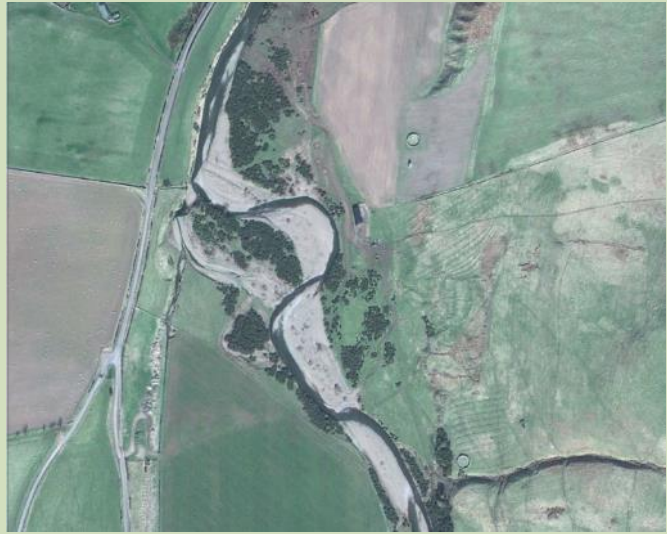
(A) January 2007

(B) March 2009

**Photo 2: Changes to river channel course and gravel deposition before (A) and after (B) the 2008 flood on Bowmont Water downstream of Attonburn (imagery from Google Earth)**

In response to the September 2008 flood, parts of the Bowmont Water experienced marked gravel

deposition and changes in channel planform (Photo 2). Further downstream the River Glen – the continuation of the river in Northumberland – was affected by the same floods and coarse sediment supply that partly originated in the Bowmont catchment (Photo 3).

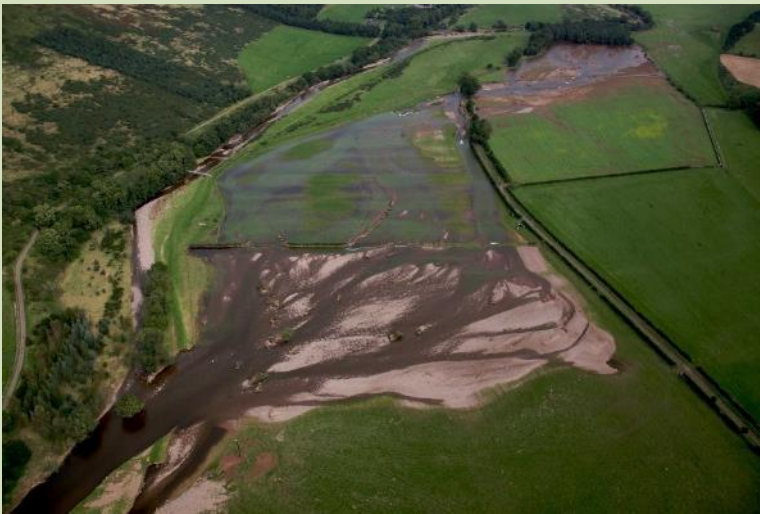
**Photo 3: An avulsion on the River Glen (downstream continuation of the Bowmont in Northumberland) caused by the September 2008 flood event. It is thought this happened in part due to excessive sediment supply from the Bowmont catchment.**

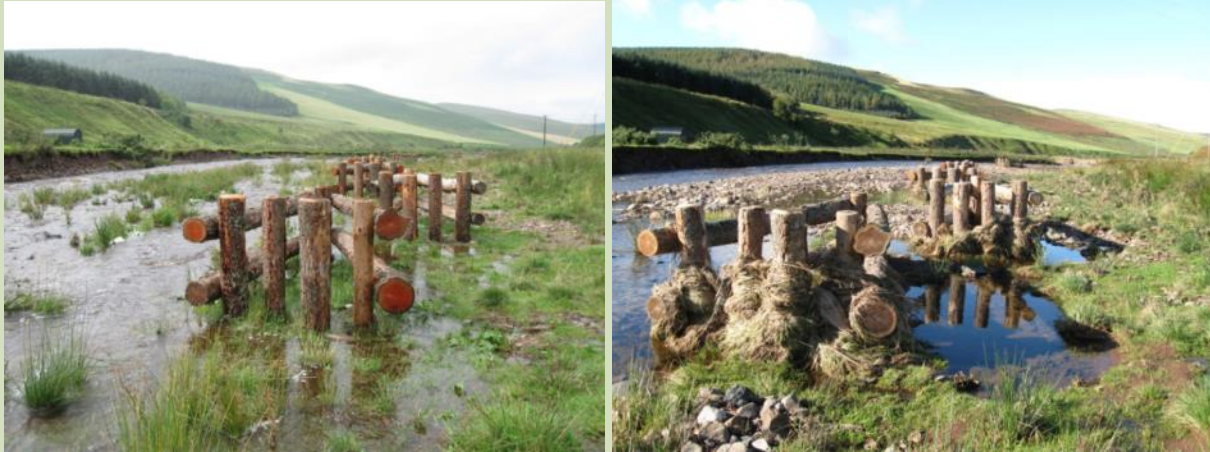
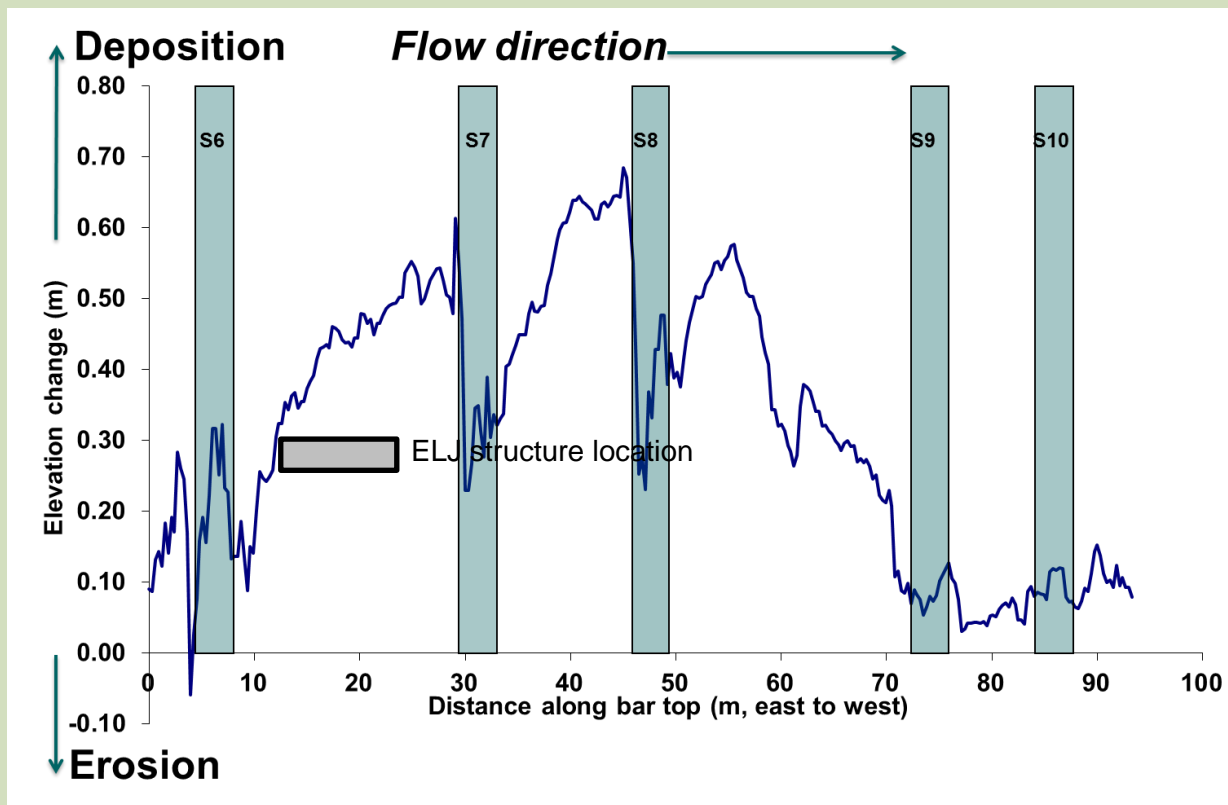
Figure 1: Top panel: Condition of bar apex ELJs on the Bowmont Water before (above left) and after (above right) a large flood (~5–10 year recurrence interval). Note the captured debris and formation of scour pockets created by the structures through re-direction of flow currents. Bottom panel: Elevation change profile showing the capture of sediment along the axis of a gravel bar in association with the ELJ locations.

Owing to the small area of planting in relation to the large catchment area, it is difficult to detect the impact the measures could have had on flood peaks but it is very unlikely that there has been an effect on flood hydrology at the catchment scale. However, leaky barrier structures (bar apex ELJs) have captured small amounts of sediment, though their sediment trapping effectiveness has been limited given their small size and porous design (Addy and Wilkinson 2016) (Figure 1).

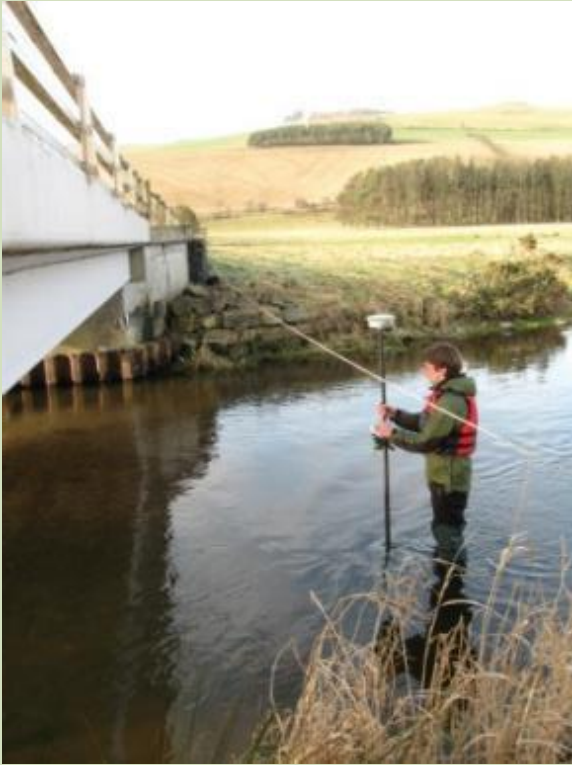
**Photo 4: Surveying river morphology on Bowmont Water near Town Yetholm**

Photos 4, 5 and 6 show some of this monitoring in action.

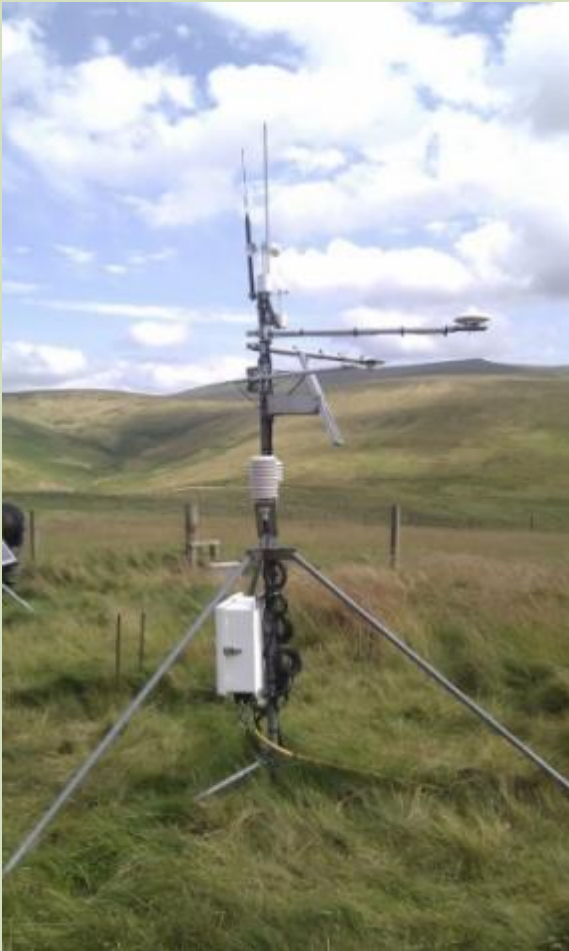
**Photo 5: Weather station at Sourhope**

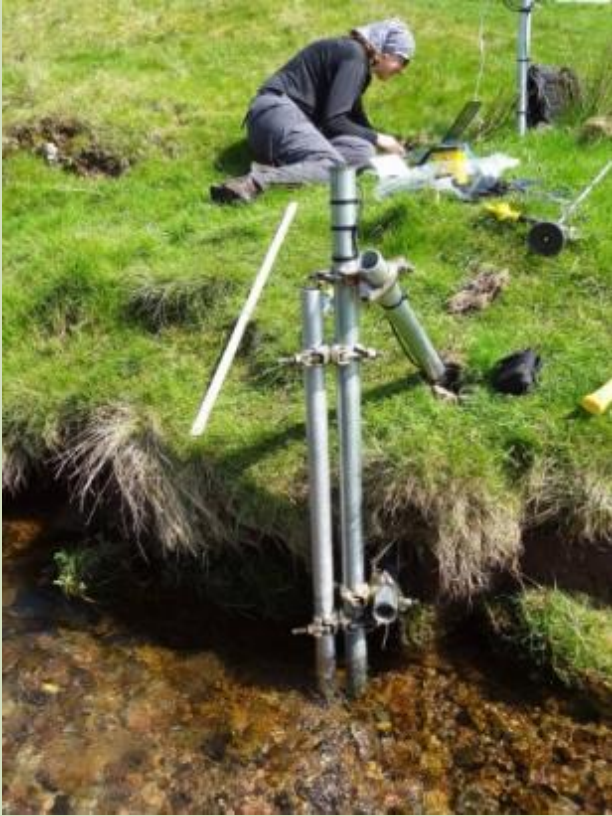
**Photo 6: Downloading data from a flow monitoring station on a headwater tributary of Bowmont Water**
