Case study 2. Mayes Brook river restoration, Mayesbrook park, east London

Main driver: Climate change adaptation and resilience

Project stage: Constructed 2012

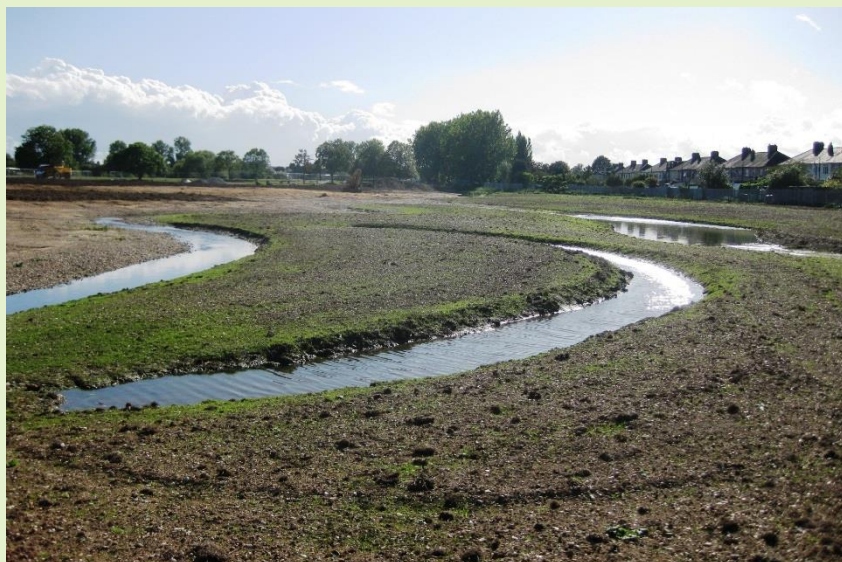
Photo 1: River floodplain restoration post-construction (source: Environment Agency)

The features and river restoration was constructed in the dry and the restored channel was reconnected to the main channel once erosion protection measures had been put in place (Photo 1).

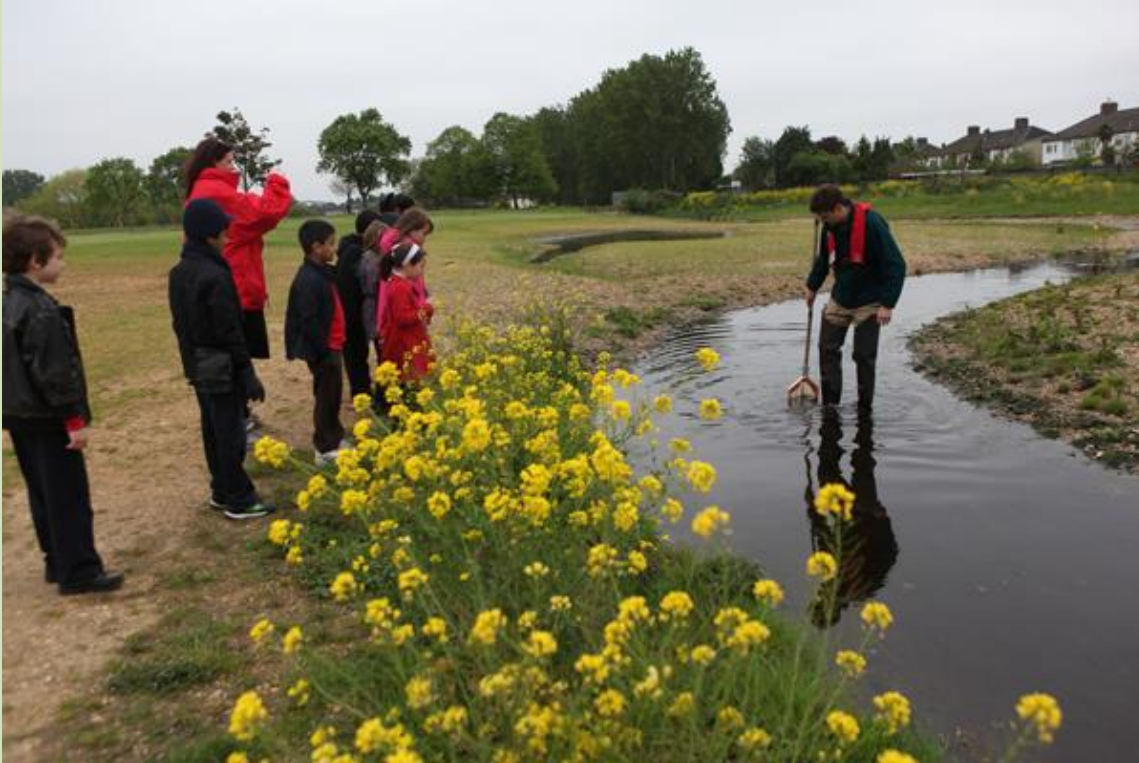
Photo 2: Monitoring works post construction (source: Environment Agency)

Photos 2 and 3 illustrate invertebrate monitoring being carried out by the Environment Agency.
