Case study 11. Low Stanger Floodplain Reconnection Project

Author: Ian Creighton

Main driver: Flood alleviation

Project stage: Completed 2015

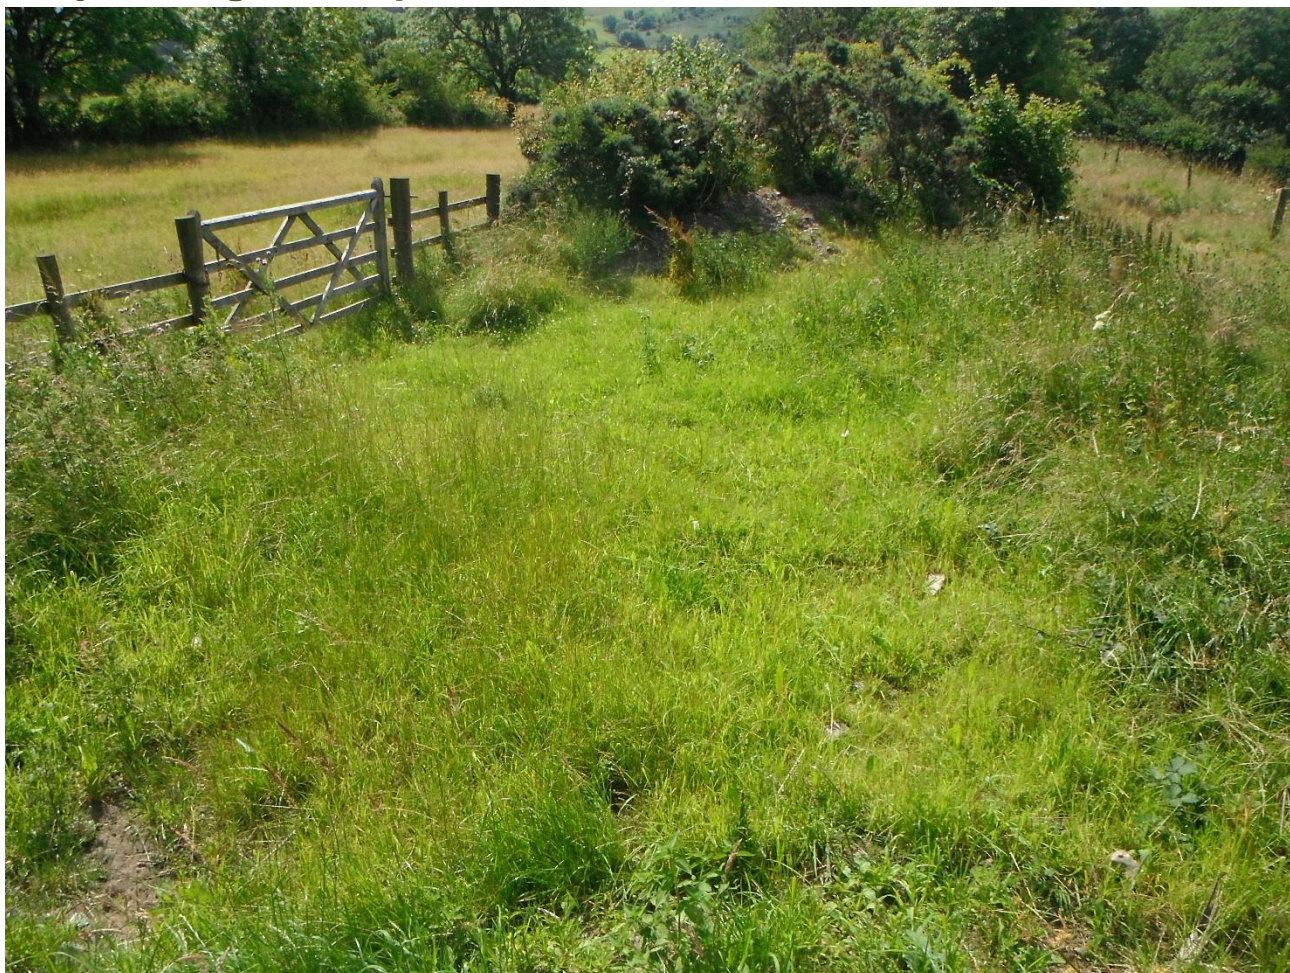
Photo 1: Downstream breach, Low Stranger Farm (source: West Cumbria Rivers Trust)

There have been significant flooding issues in the town of Cockermouth in recent years. A new flood defence scheme was constructed in 2014, which was overtopped by Storm Desmond in December 2015. There is no single solution and it will need multiple and varied solutions working with landowners to help flatten the flood peak in order to reduce future flood risk. At Low Stanger Farm (see Map 1), the existing flood embankment was breached along 4 sections to increase flood storage when the River Cocker is out of channel (Photo 1).
