Case study 39. Dunruchan Farm Peatland Restoration Project

Main driver: Natural Flood Management (NFM)

Project stage: Constructed 2016

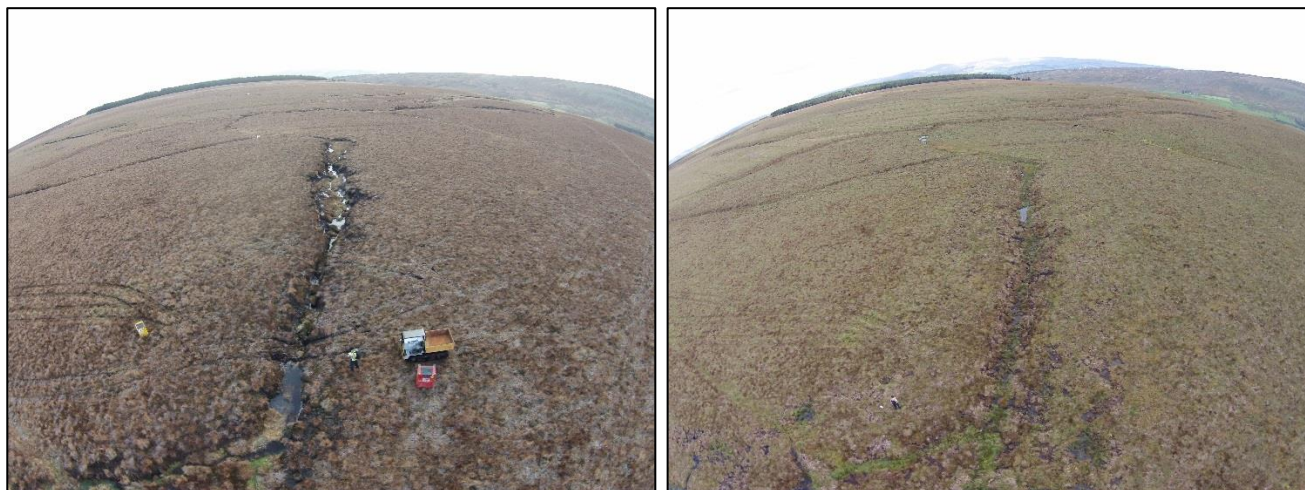
Photo 1: (A) Dunruchan Farm before peatland restoration work began in January 2016. (B) The same location following work in September 2016 (source: River Forth Rivers Trust).
