SAFAG-report to Shipston Town Council-December 2025.

Severn Rivers Trust (SRT) have successfully secured CIL funding of £60K from SDC to cover various pipeline (spade ready) projects, under the project title of 'Shipston on Stour Natural Flood Management Advanced'.

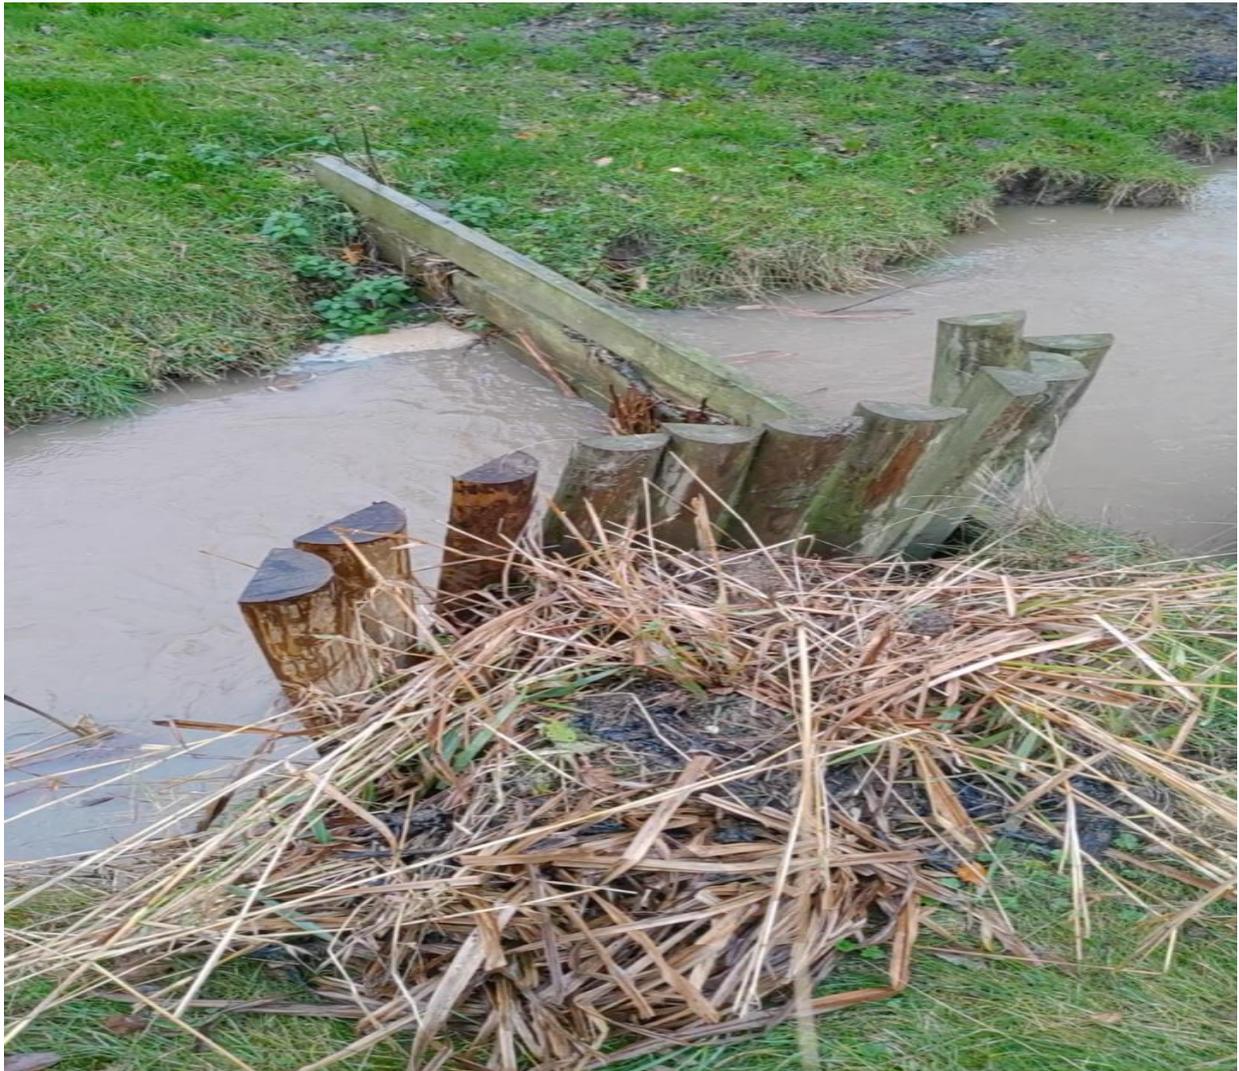
Ben Goren ventured out on 14th November, during the heavy rainfall, to check the leaky dams on Sutton Brook in Brailles. Some photos were taken.

The picture below shows the situation before the peak levels of water flow. It was expected that, within a few hours, the level would've risen further. It illustrates the volume and force of flood water which the dams face in spate conditions.

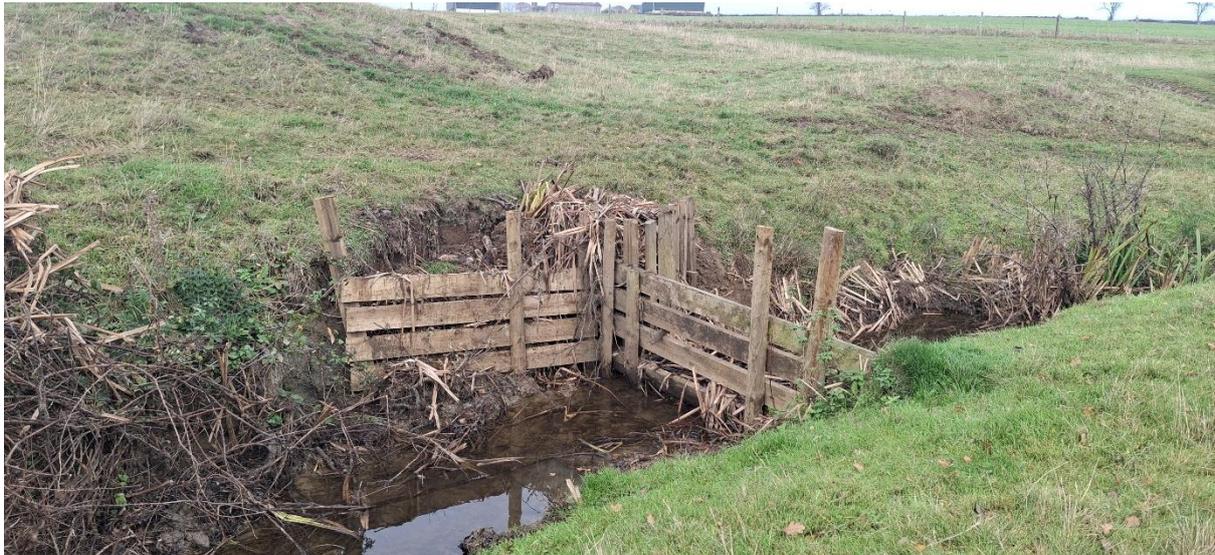
From the October report. The repairs/upgrades to the leaky dams on Sutton Brook at Brailes have been completed. It was touch and go whether this would have to be deferred until next year due to concerns about the ground and weather conditions, as well as contractor availability

A picture of one of the repaired dams is shown below.

Note the support required to stabilise the bank of the watercourse. This type of erosion is now becoming a regular problem.

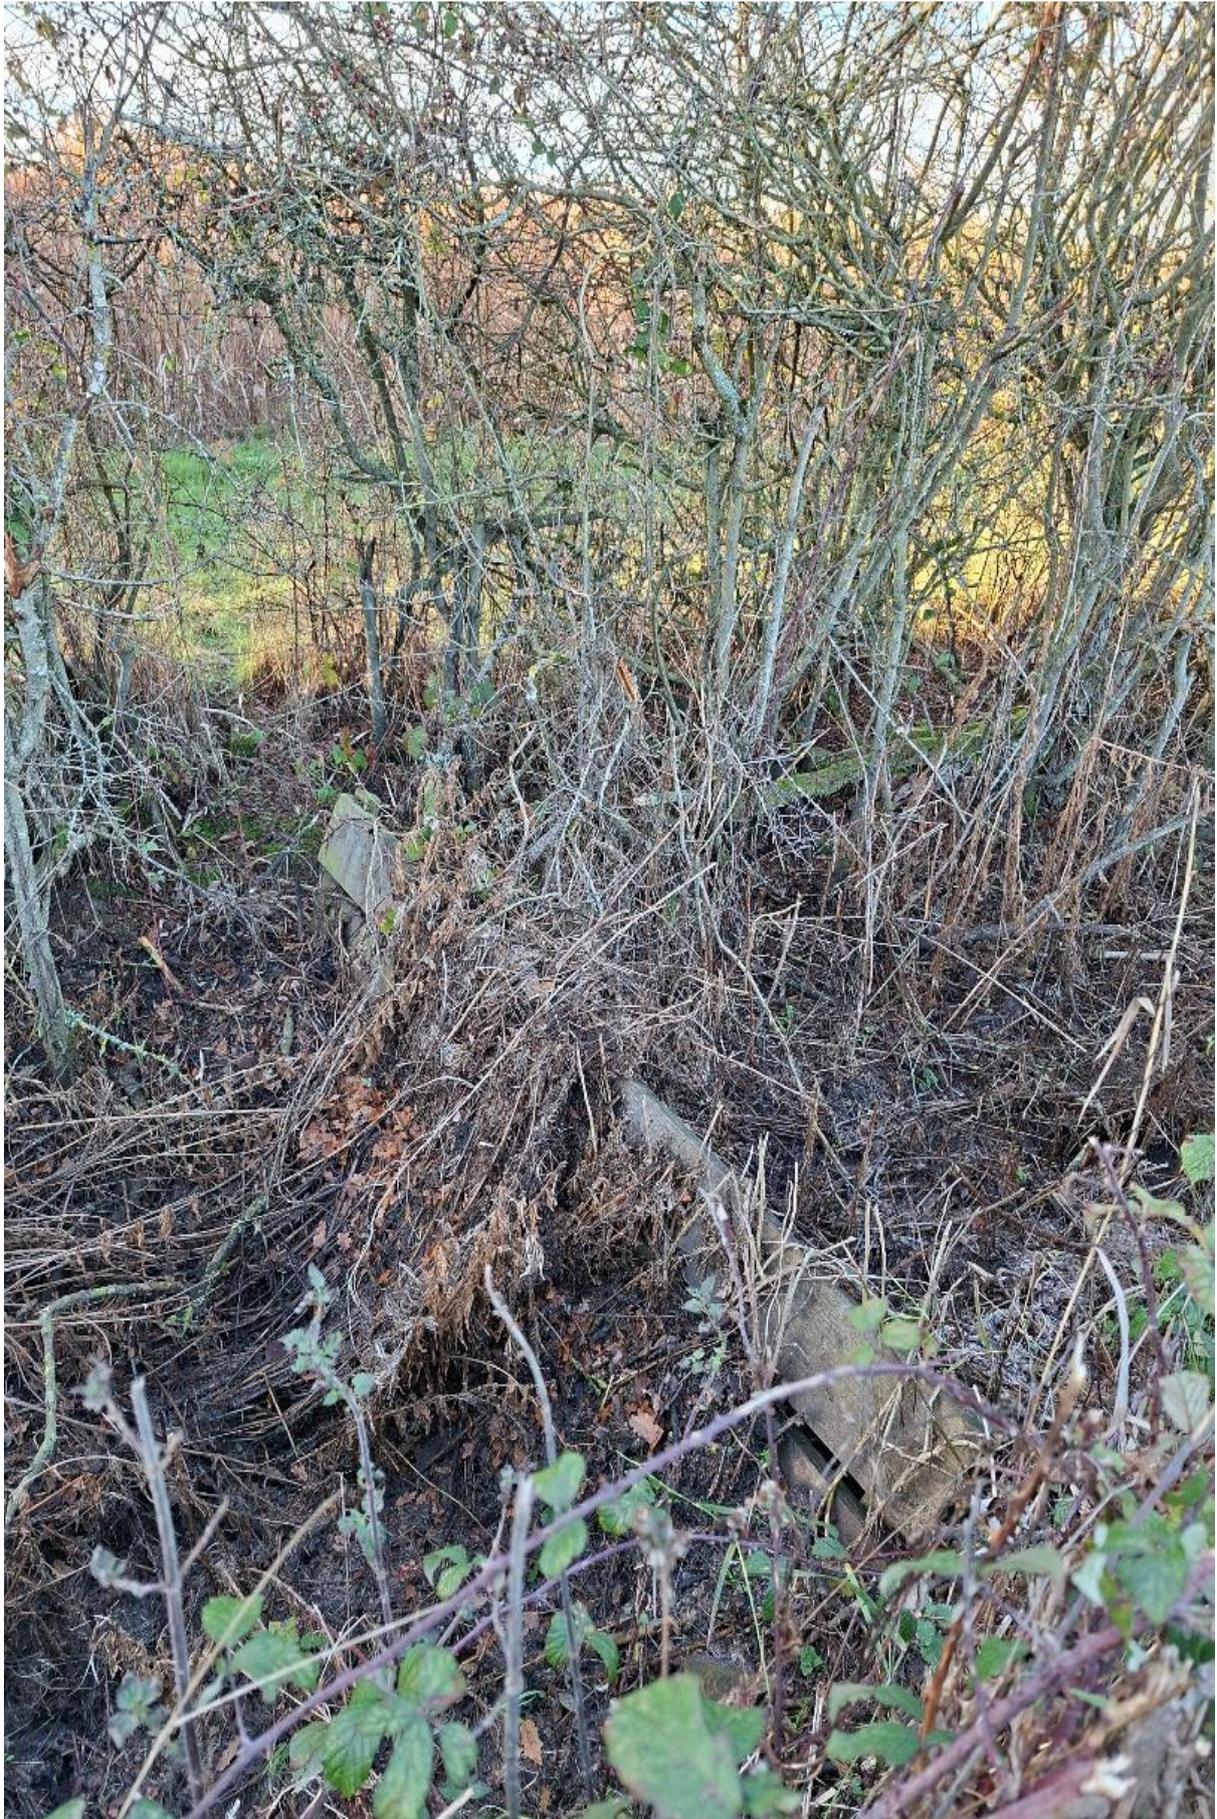
The first section of Pig Brook (Ditchford Farm), including those on the side stream, comprised of 1 bund (in good condition) and 10 dams, one of which was leaning slightly.

Some were silting up which inhibited the water flow and others were affected by excessive build-up of vegetation debris

A photo of the leaning dam (with debris vegetation) is at the end of this report, together with a picture of the large bund.

The first picture below shows the leaning dam at Ditchford Farm (on the side stream feeding into Pig Brook), with the vegetation debris which has built up. A few of the others were similarly affected by this type of debris.

It's likely that any remedial work can be carried out by the SAFAG team, when conditions are better suited. This will be discussed at the next team meeting.

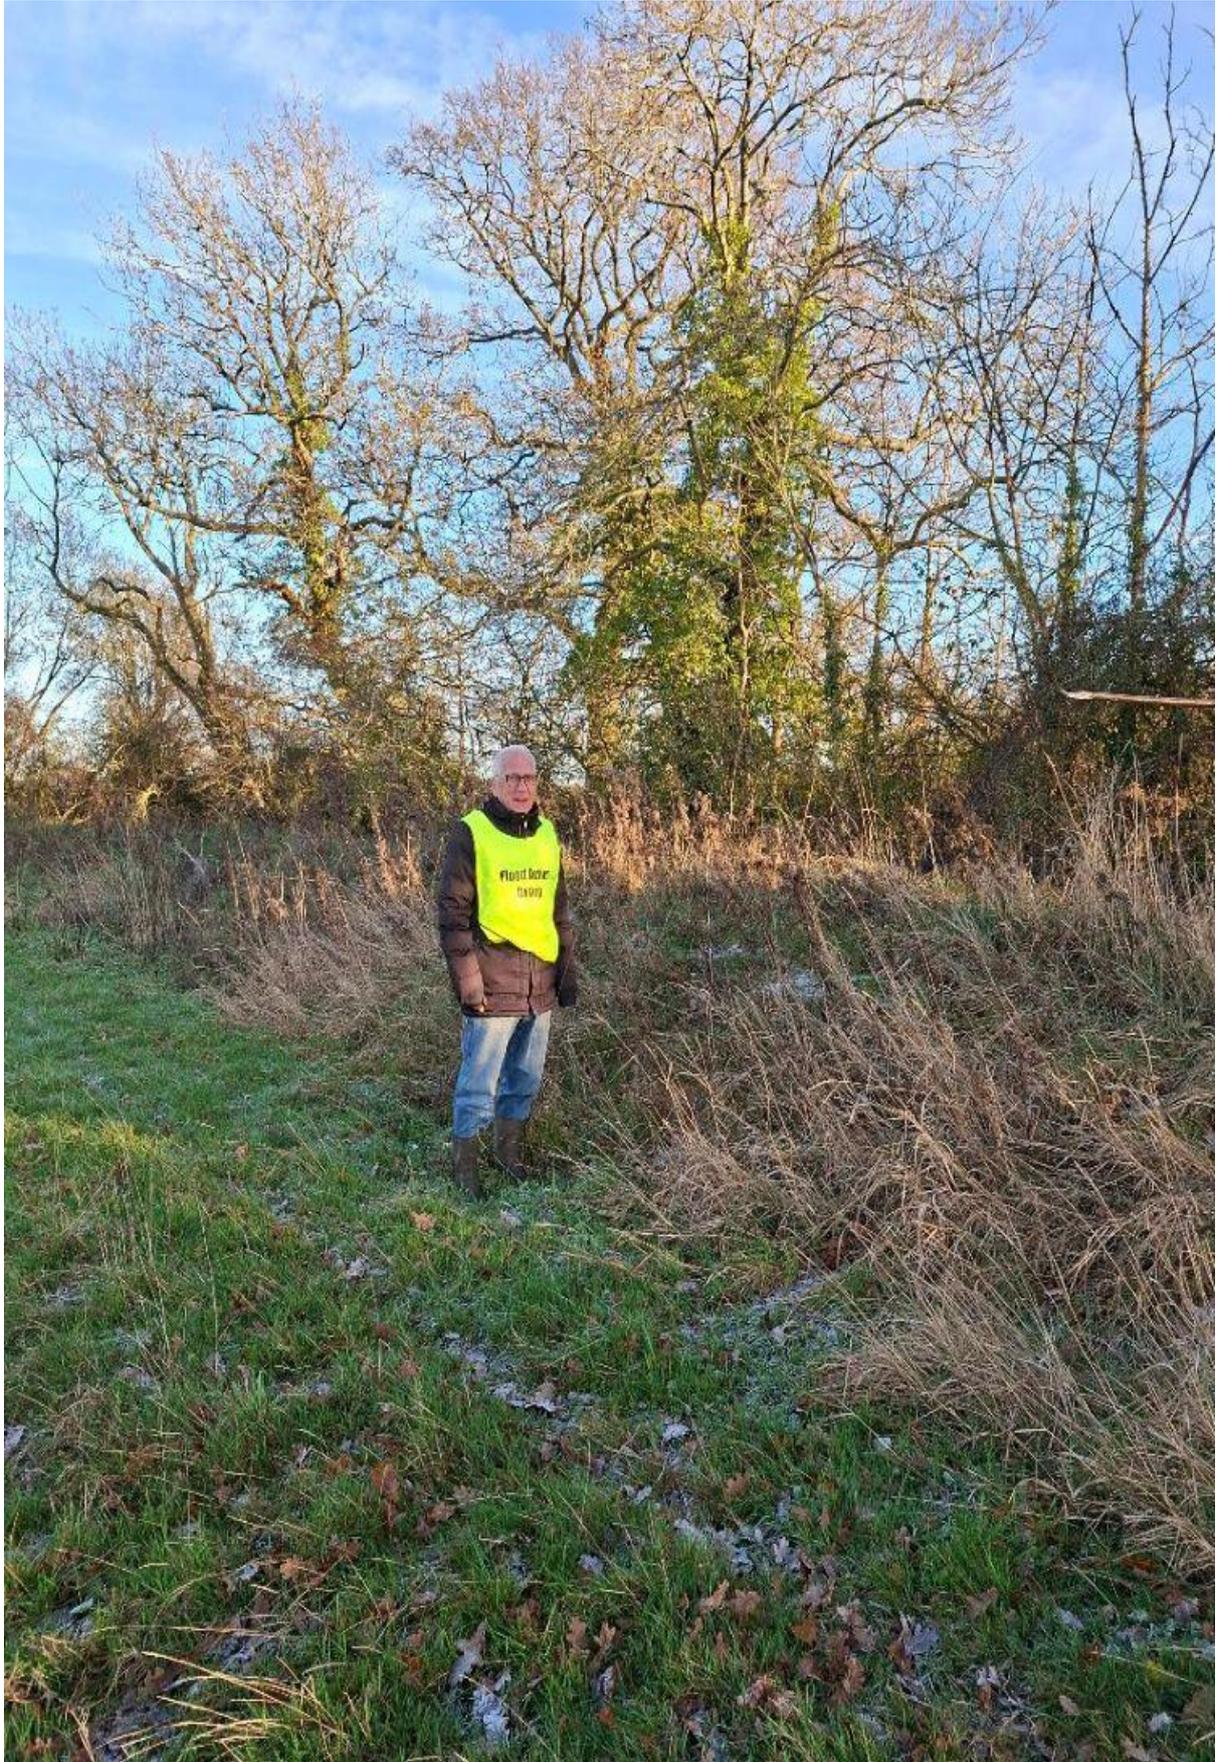
The second picture below shows the bund at the bottom of the Ditchford Farm section of Pig Brook. It's large and, in places, is more than 1m high. The scale can be appreciated by reference to Dave Passingham standing in front of the bund. It has an entry and exit pipe, allowing for the gradual discharge of water from the field into Pig Brook, which is behind the bund and in front of the hedgerow in the background.
